USAAVLABS TECHNICAL REPORT 66-10

XV-9A HOT CYCLE RESEARCH AIRCRAFT PROGRAM

SUMMARY REPORT

HUGHES TOOL COMPANY
CULVER CITY, CALIFORNIA

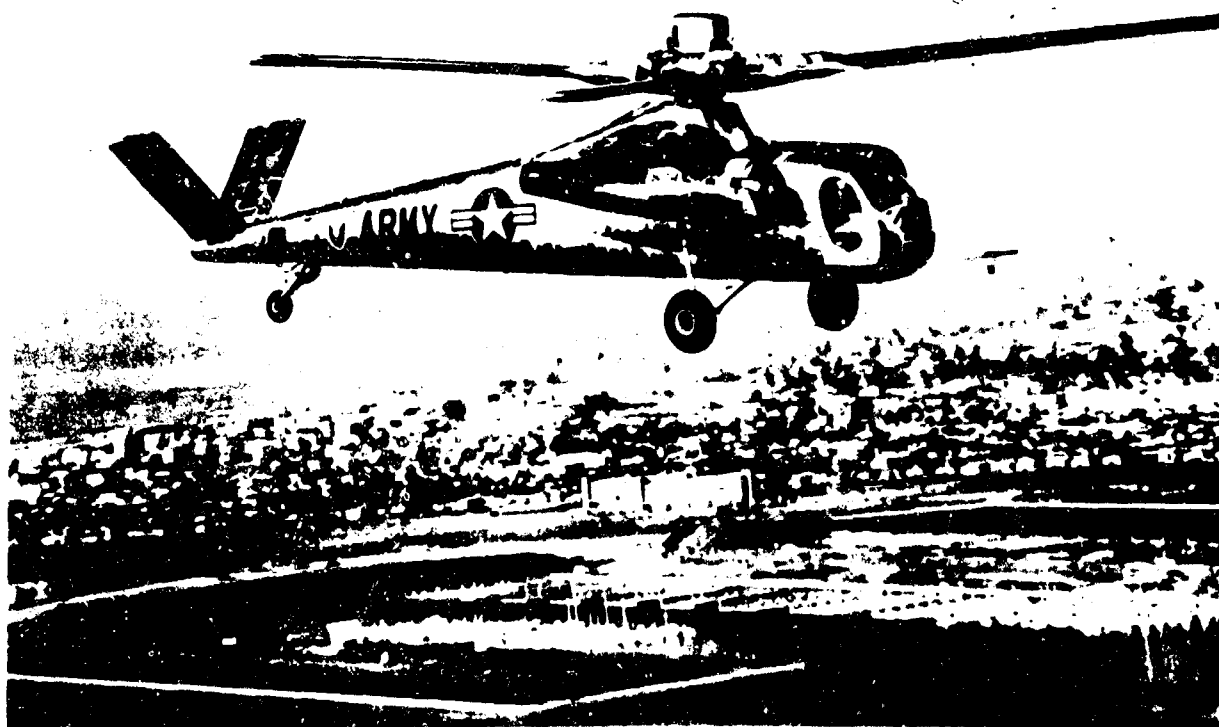
Figure 1. XV-9A Hot Cycle Research Aircraft.

The design, fabrication, and test of the XV-9A Hot Cycle Research Aircraft (Figure 1) have been accomplished in accordance with U.S. Army Aviation Materiel Laboratories Contract DA 44-177-AMC-877(T). This report summarizes the program and delineates significant results, conclusions, and recommendations derived therefrom.
